Hudson Heritage Project

Building Demolition Application

Route 9
Town of Poughkeepsie
Dutchess County, New York

January 14, 2016
REVISED
February 24, 2016

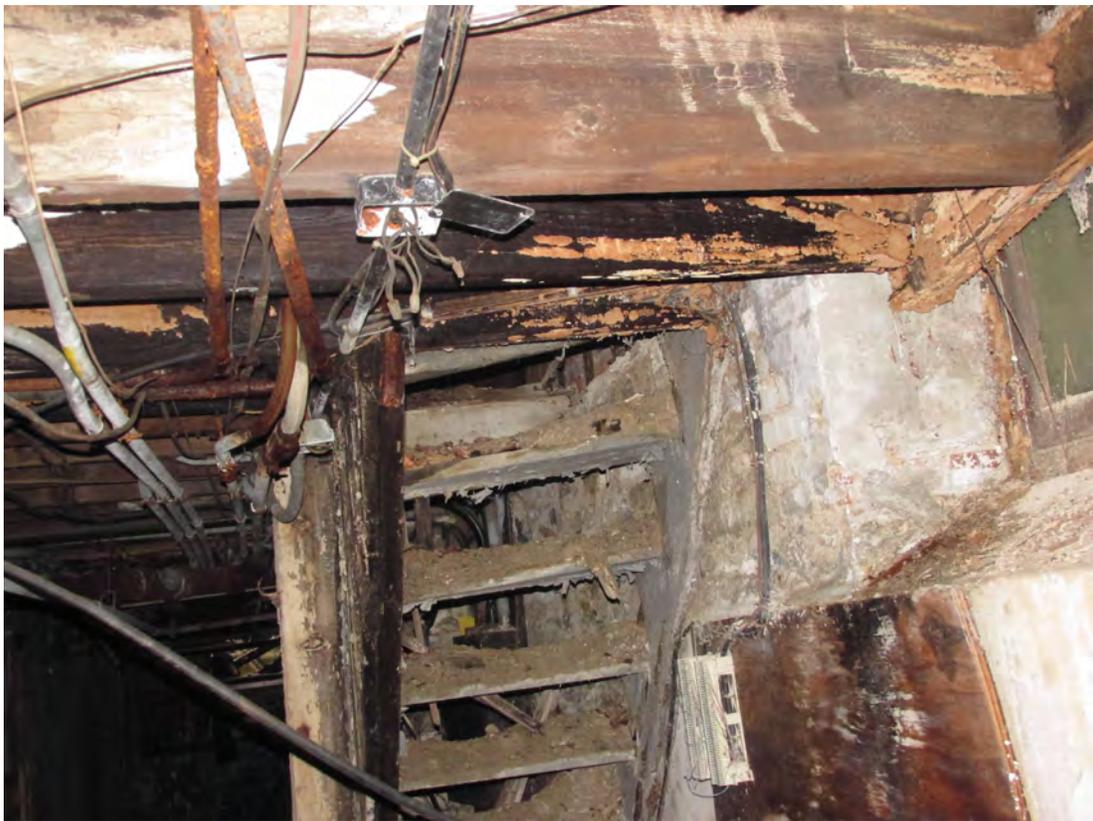
Photo No. 4

The existing building is a wood and brick structure, three stories high with a basement area. The building has been abandoned for many years and subject to vandals who have broken into the building to steal salvageable metal. In addition, a large portion of the building has been destroyed from a fire (Photos No. 1 and No. 2). The building structure is not sound, with the roof having been penetrated, even in areas not destroyed by the fire, therefore allowing water and snow to infiltrate the framing. Evidence of damage to the second floor framing is abundant even in locations that have not collapsed (Photo No. 3). Observations made in the basement (Photo No. 4) found extensive damage to the first floor framing members.

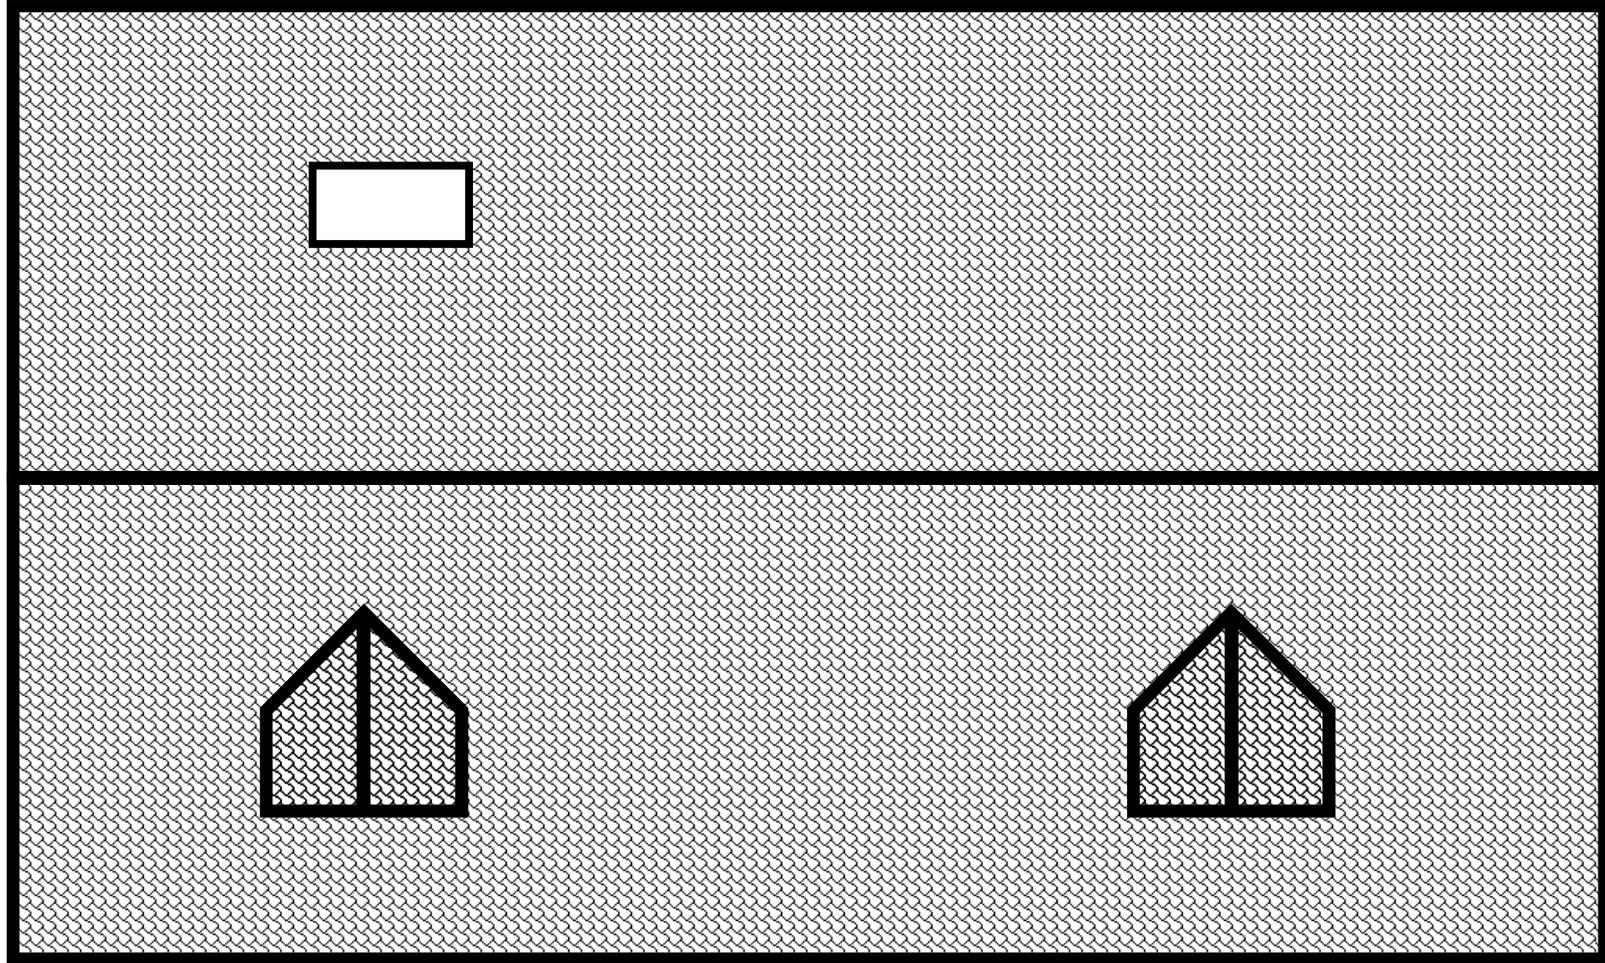
EFG/DRA HERITAGE, LLC
FORMER HUDSON RIVER PSYCHIATRIC CENTER
3532 NORTH ROAD, POUGHKEEPSIE, NY 12601
STAFF HOUSE 23
EXTERIOR-ROOF

1. ACM Shingle Debris on the Ground Throughout the Perimeter of Staff House #23.
(See Report For Details)

- 1) ACM Shingle Debris was observed on the ground throughout the perimeter of Staff House #23. **QuES&T** recommends completion of a thorough contamination assessment and preparation/ submittal of a site specific variance to NYSDOL Engineering Services Unit to address the cleanup of identified ACM Shingle Debris throughout the above-referenced location(s). Access to the affected area(s) should be restricted until the assessment and cleanup of impacted areas is completed.

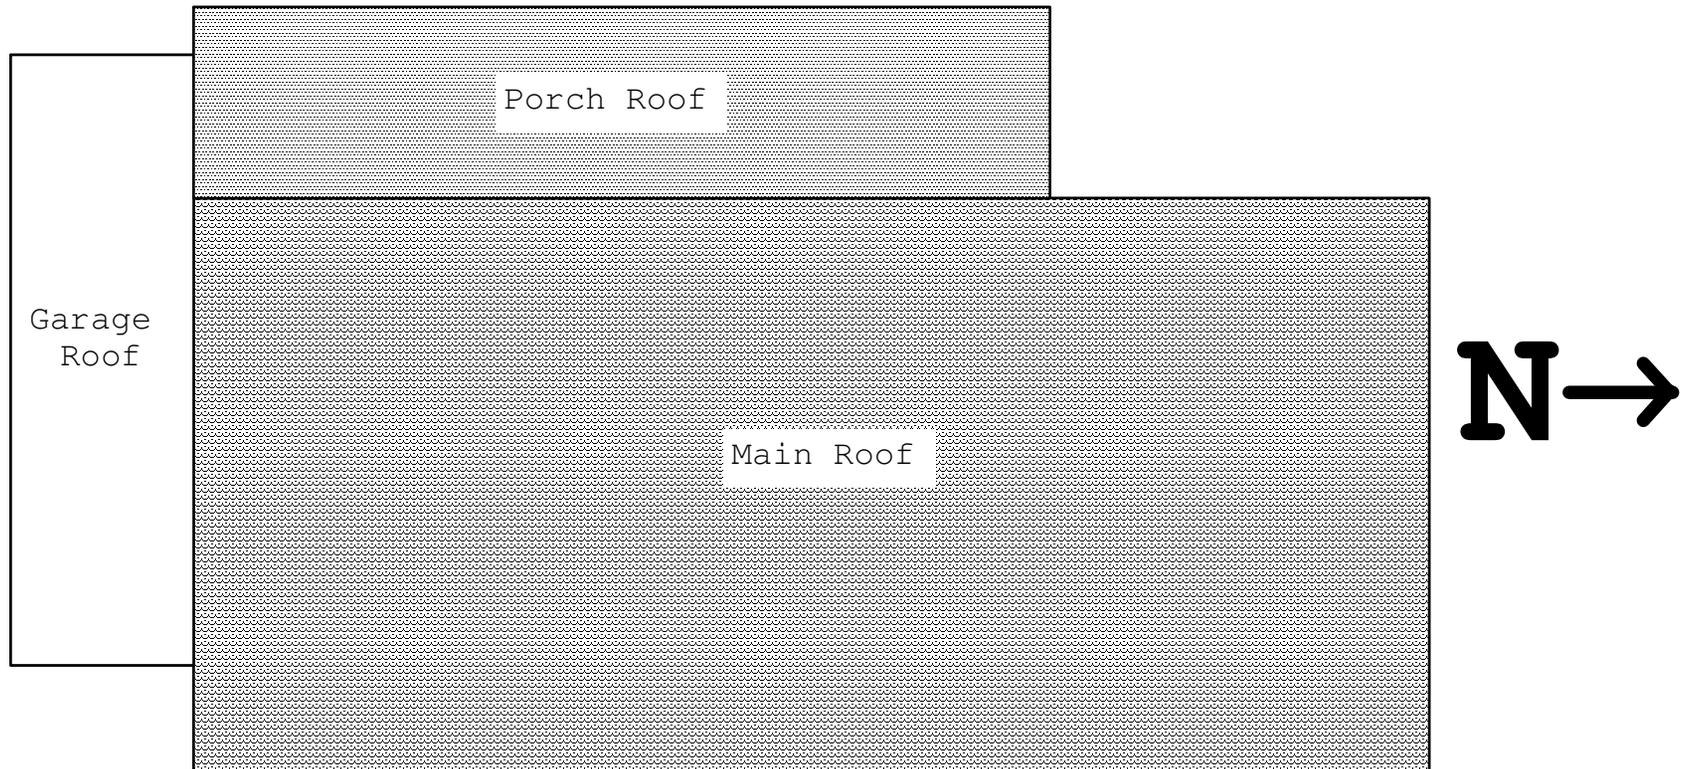
ACM Locations: Exteriors

NOTE: ACM Glazing Compound on Window Glass Perimeters Throughout

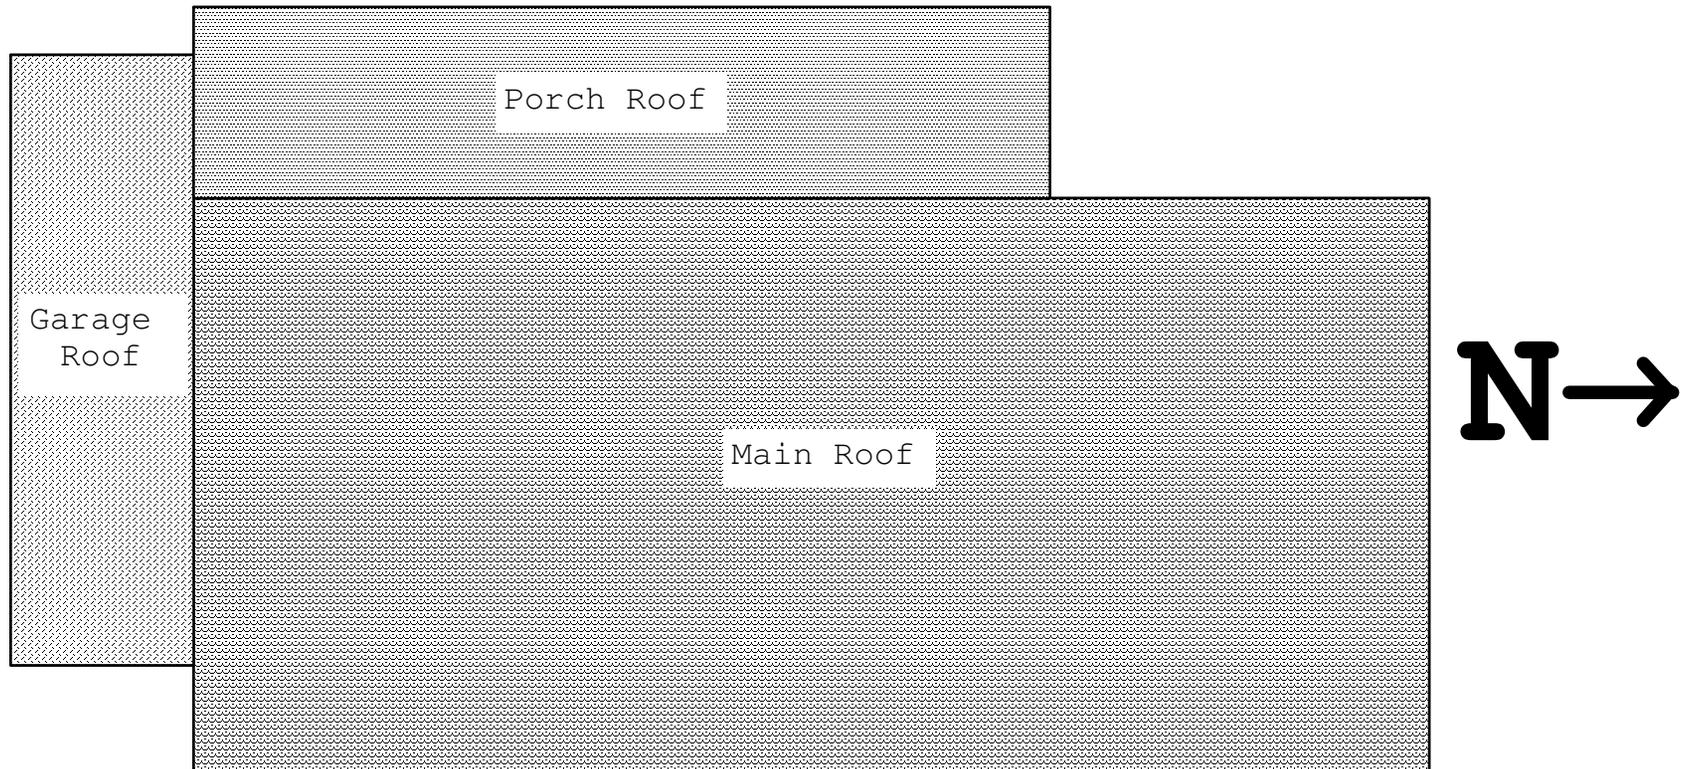
ACM Locations: Exteriors

NOTE: ACM Glazing Compound on Window Glass Perimeters Throughout
