Re: Phase I Environmental Site Assessment  
Hudson River Psychiatric Center  
373 North Road  
Poughkeepsie, New York  
PSI Project No.: 821-6E052

**PHASE I**  
**ENVIRONMENTAL SITE ASSESSMENT**

**HUDSON RIVER PSYCHIATRIC CENTER**  
**373 NORTH ROAD**  
**POUGHKEEPSIE, NEW YORK**

**PSI Project Number: 821-6E052**

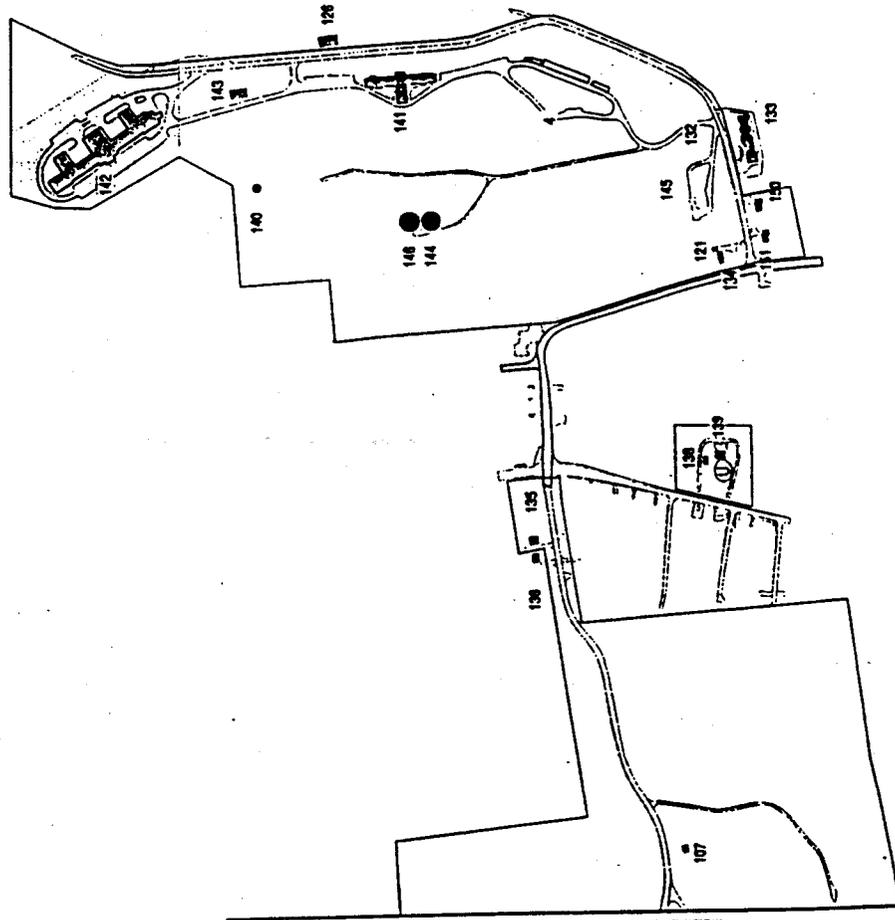
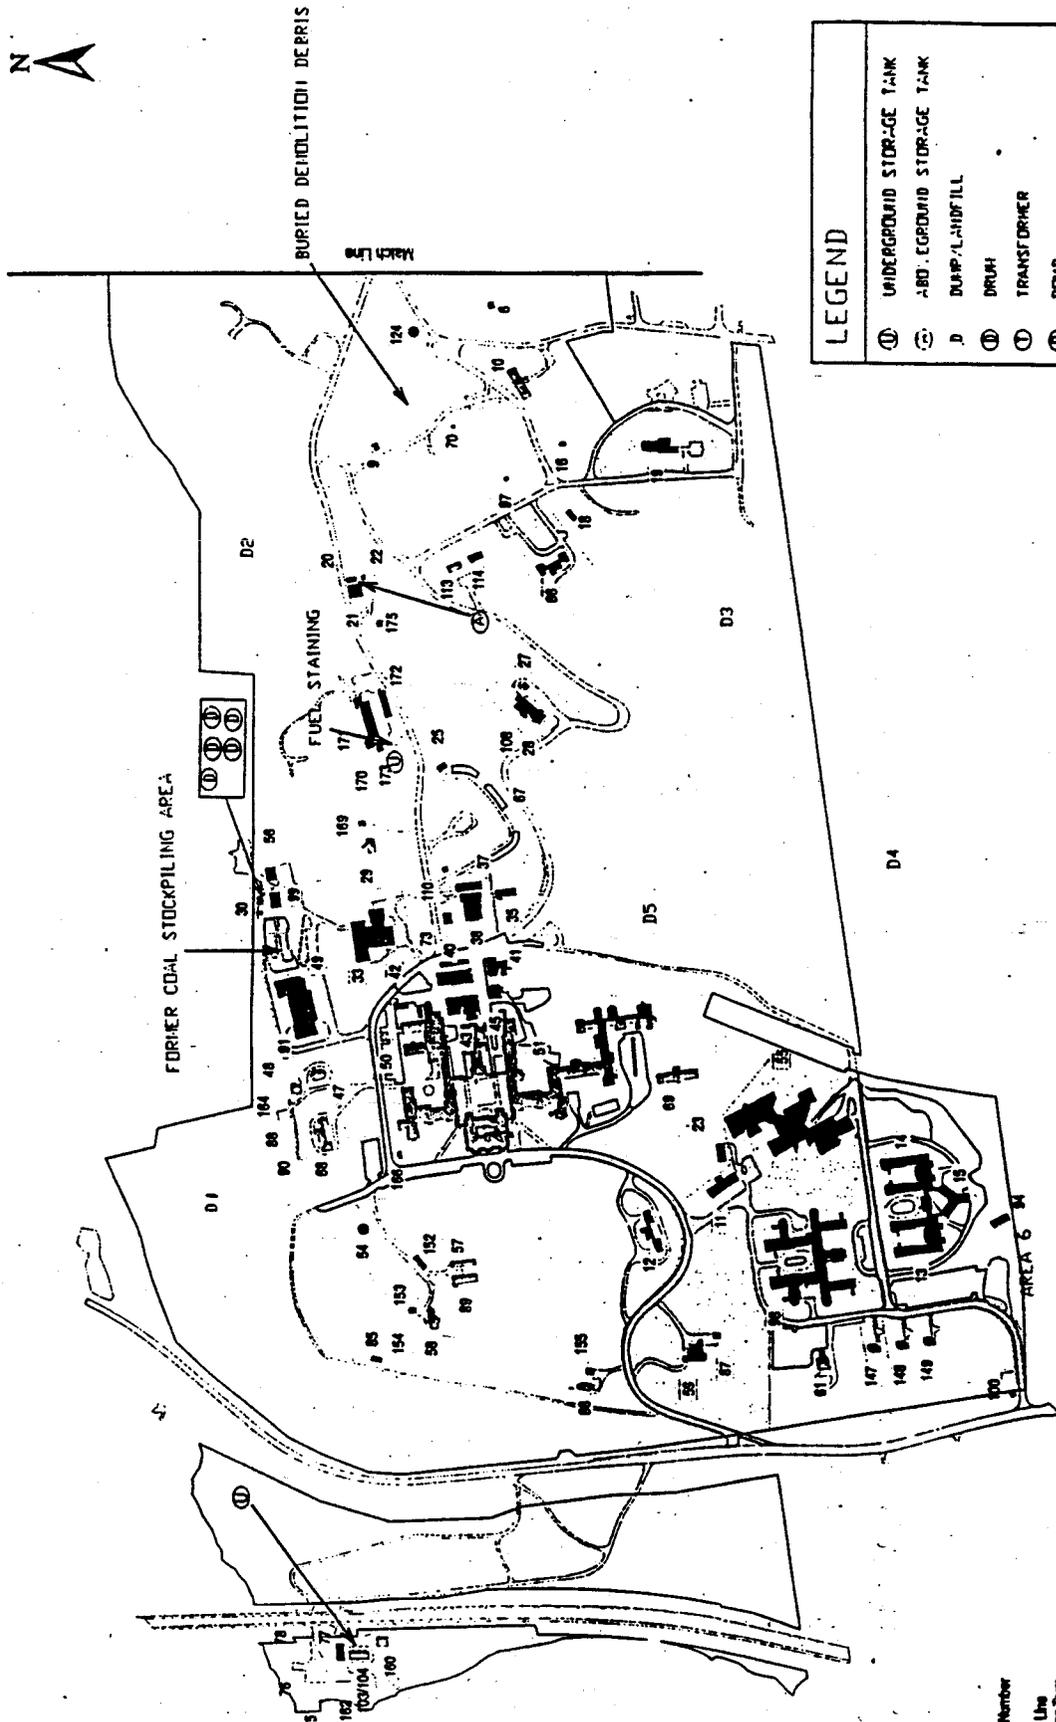
A site plan provided to PSI by the Empire State Development Corporation is contained in Appendix A. This site plan was revised to show exterior recognized environmental conditions and other pertinent items.

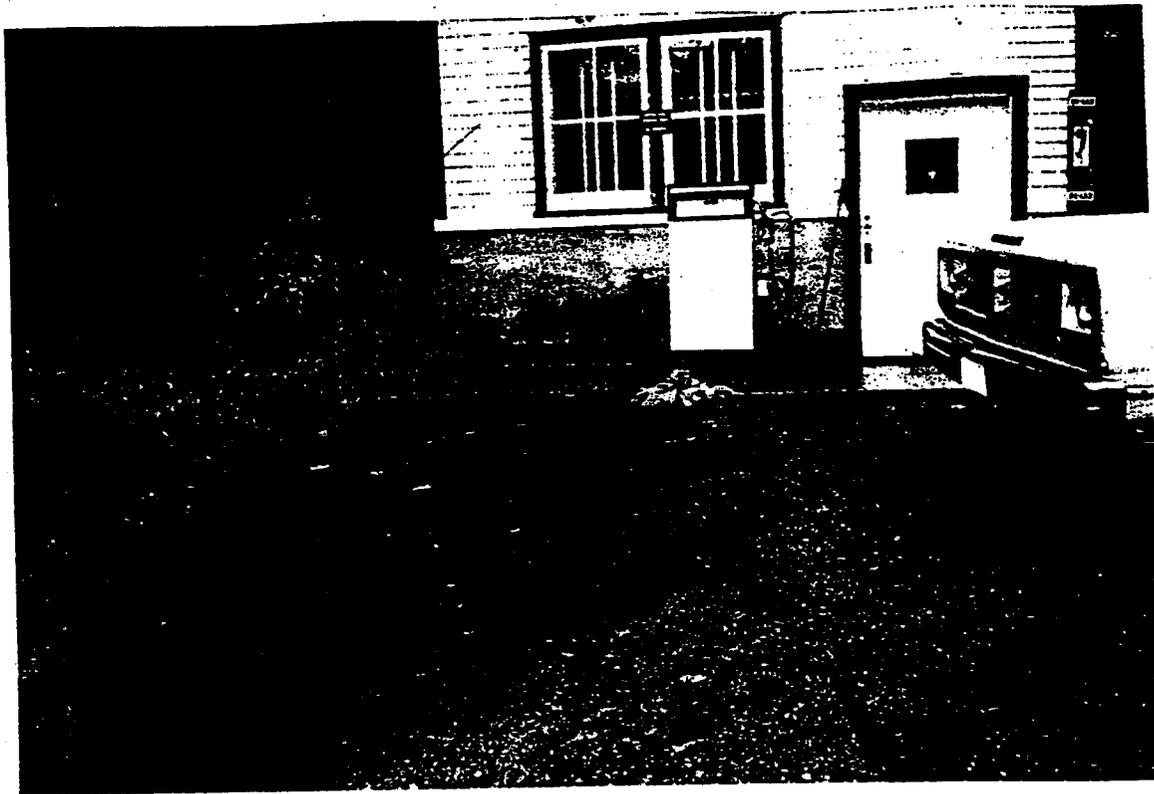
- Building 173 - Building 173 contains a diesel fuel pumping station used to service HRPC facility vehicles. An approximately 150 square foot diesel fuel stain was observed on the asphalt parking area adjacent to this structure. The asphalt was observed to be deteriorating in the area of the stain. This asphalt area slopes toward a roadside storm drain and diesel fuel was observed to be migrating to the drain. Based on the possibility of subsurface contamination to exist at this location, the potential environmental impact of this spilled fuel on the subject site is considered to be significant.

(9) Looking North at Diesel Fuel Pumping Station and Diesel Fuel Staining on the South Side of On-Site Building 173.

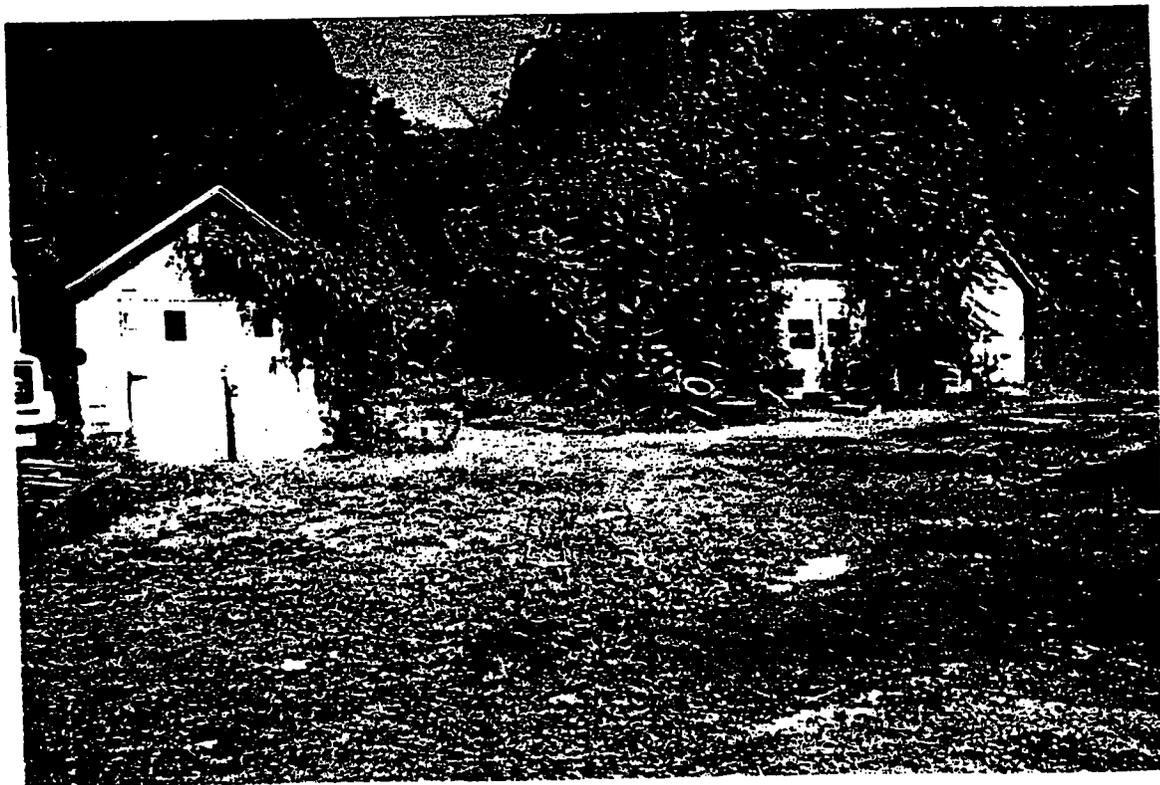
- Building 30 - Building 30 consists of three storage sheds and is located to the north of the HRPC garage Building 99. Fifteen 55-gallon drums were observed sitting on the ground between the east and middle shed. The drums reportedly contain waste oil. An approximately 200 square foot stain was observed beneath these drums. The potential environmental impact due to soil and subsurface contamination at this location is considered to be significant.

(10) Looking Northeast at On-Site Building 30 Drum Storage Sheds.

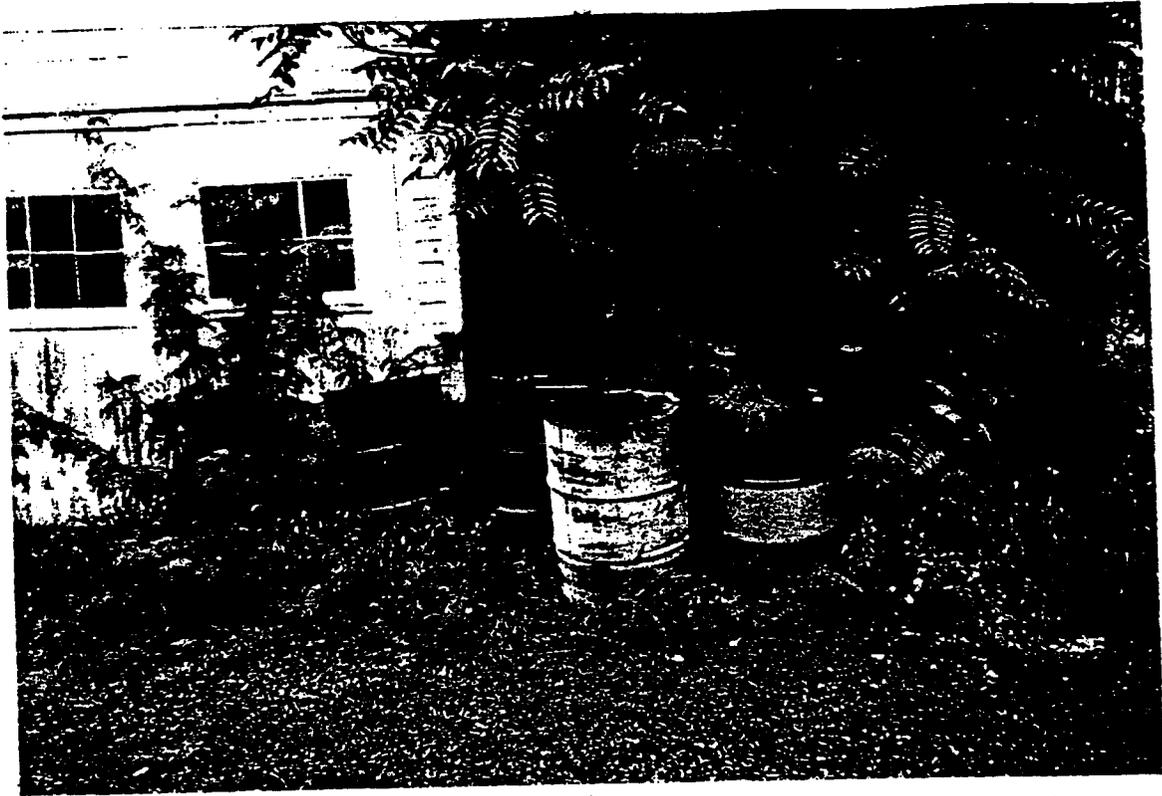
Three storage sheds, identified as Building #30 are used for facility vehicle fluid and waste oil storage. The west shed contained twenty 55-gallon drums, ten of which contained motor oil with no apparent staining evident. The middle shed contained ten 55-gallon drums, five of which reportedly contained waste oil, with no staining evident. Between the middle and the east shed, fifteen 55-gallon shed drums were observed. These drums reportedly contained motor oil and waste oil. About a 200 square feet of ground beneath these drums was stained. Based on this information, the potential environmental impact of this tank on the subject site is considered to be significant.

(11) Looking North at Waste Oil Storage Drums on the Exterior of On-Site Building 30 Storage Sheds.

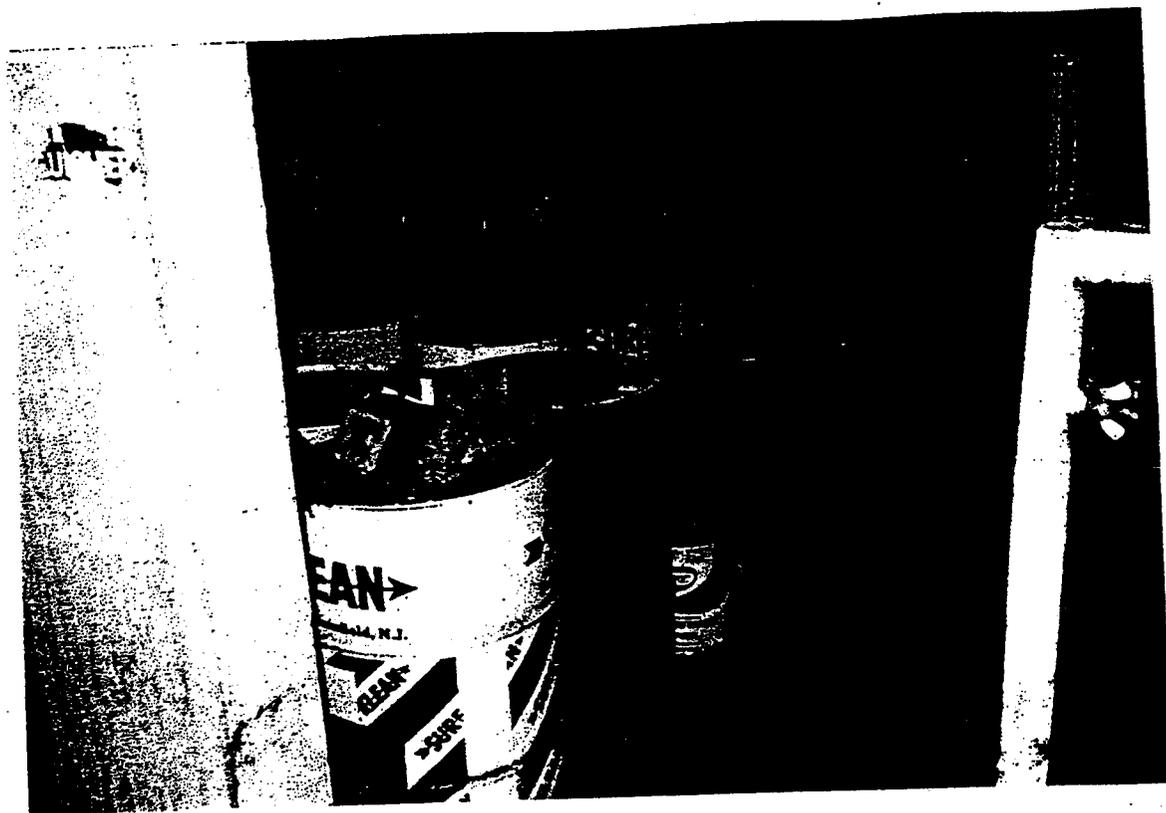
Storage garage (Building 20) is used as a storage room for the on-site paint shop Building #21. During on-site reconnaissance, 16 55-gallon steel drums were observed in the building. The drums reportedly contained paint thinners and paint stripping solvents. The drums all appeared to be in good condition. About a 20 square foot stained area was observed on the concrete floor beneath these drums, however, the stain was contained and confined to the floor area. Based on the good condition of these drums, the potential environmental impact of the drums on the subject site is considered to be low.

(15) Looking North at Paint Thinner/Solvent Storage Drums in On-Site Building 20.

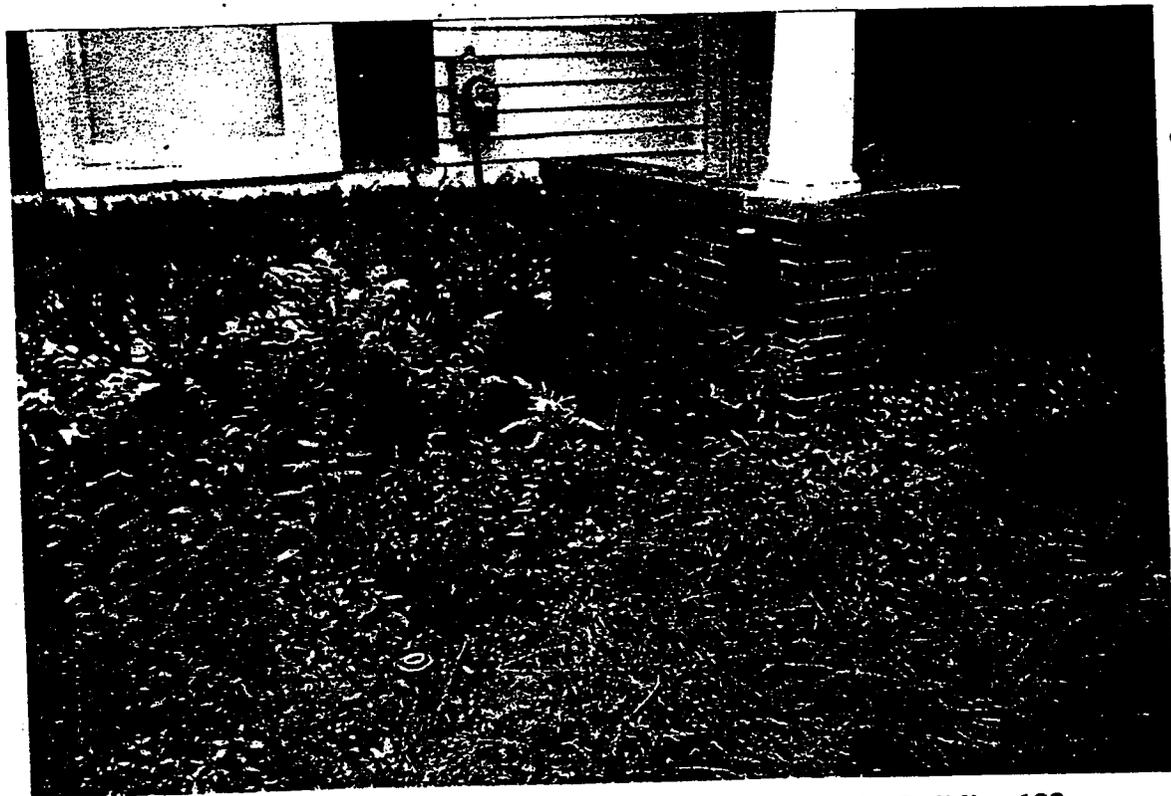
(16) Looking East at UST Vent and Fill Pipes at On-Site Building 122.

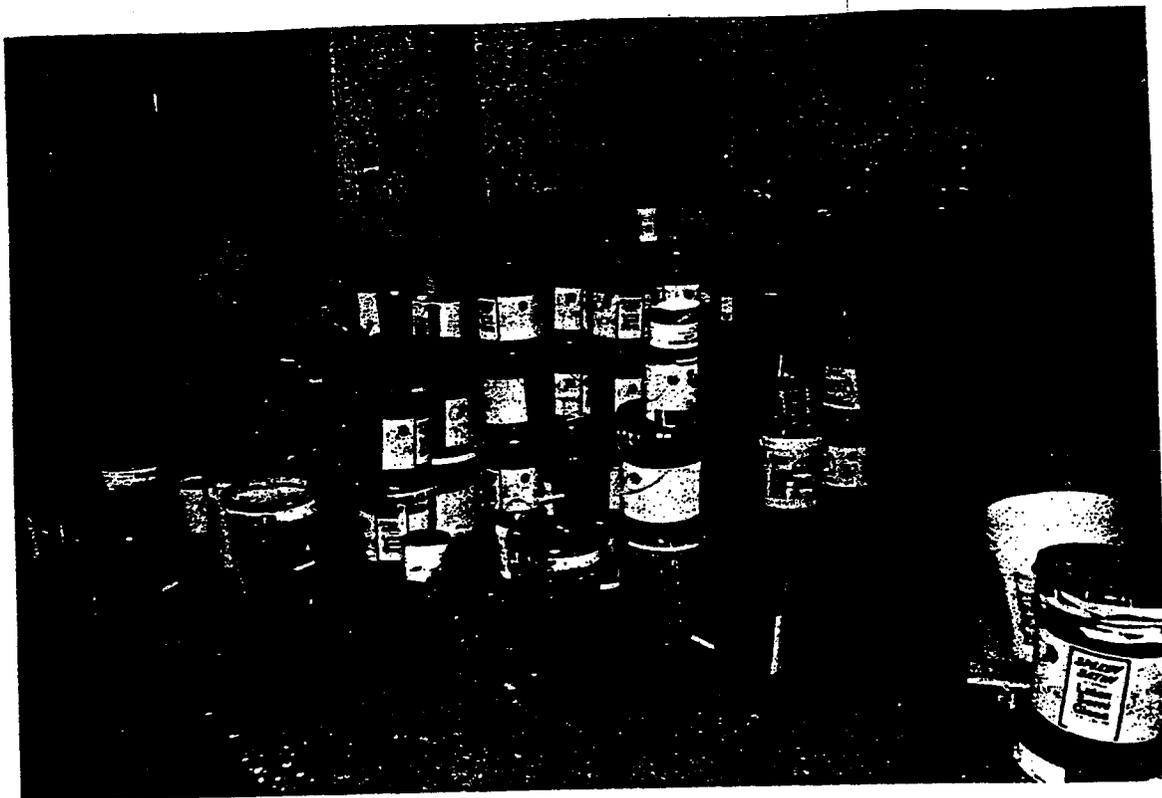
(19) Looking Southwest at Paint Storage in On-Site Building 21 Paint Shop.

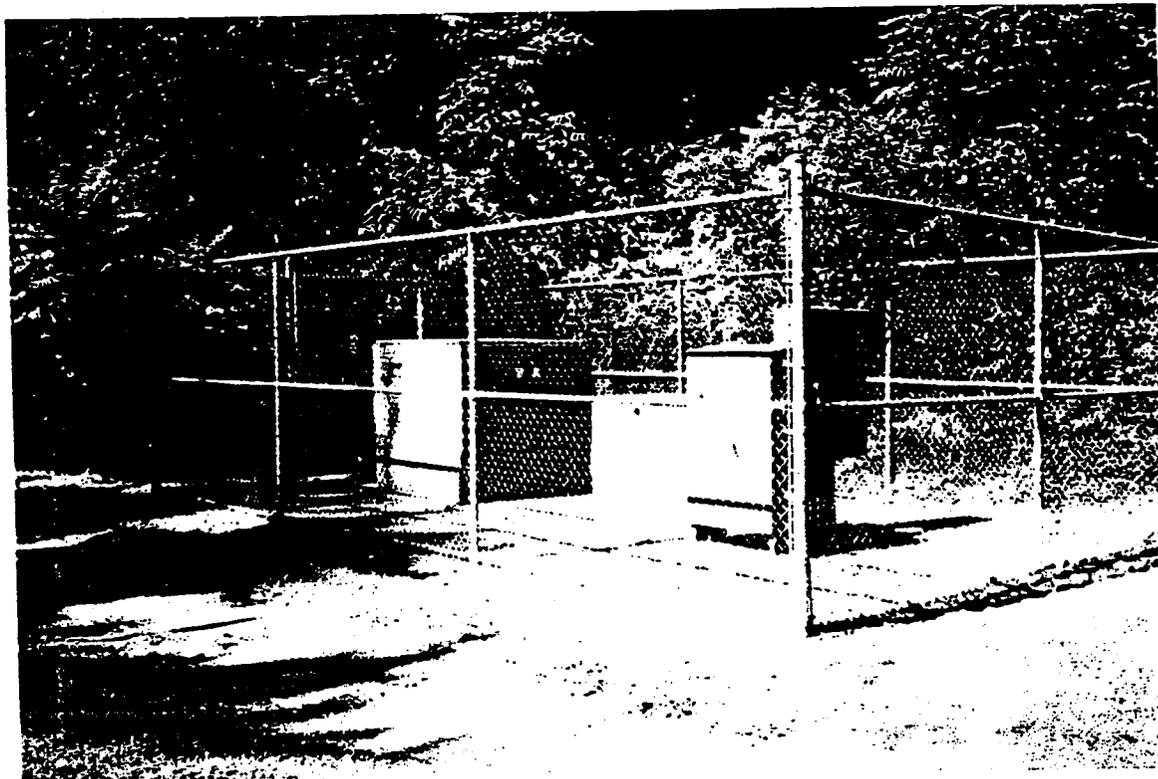
(20) Looking Northwest at Typical Pad-Mounted Transformer Pad to the South of On-Site Building 173.

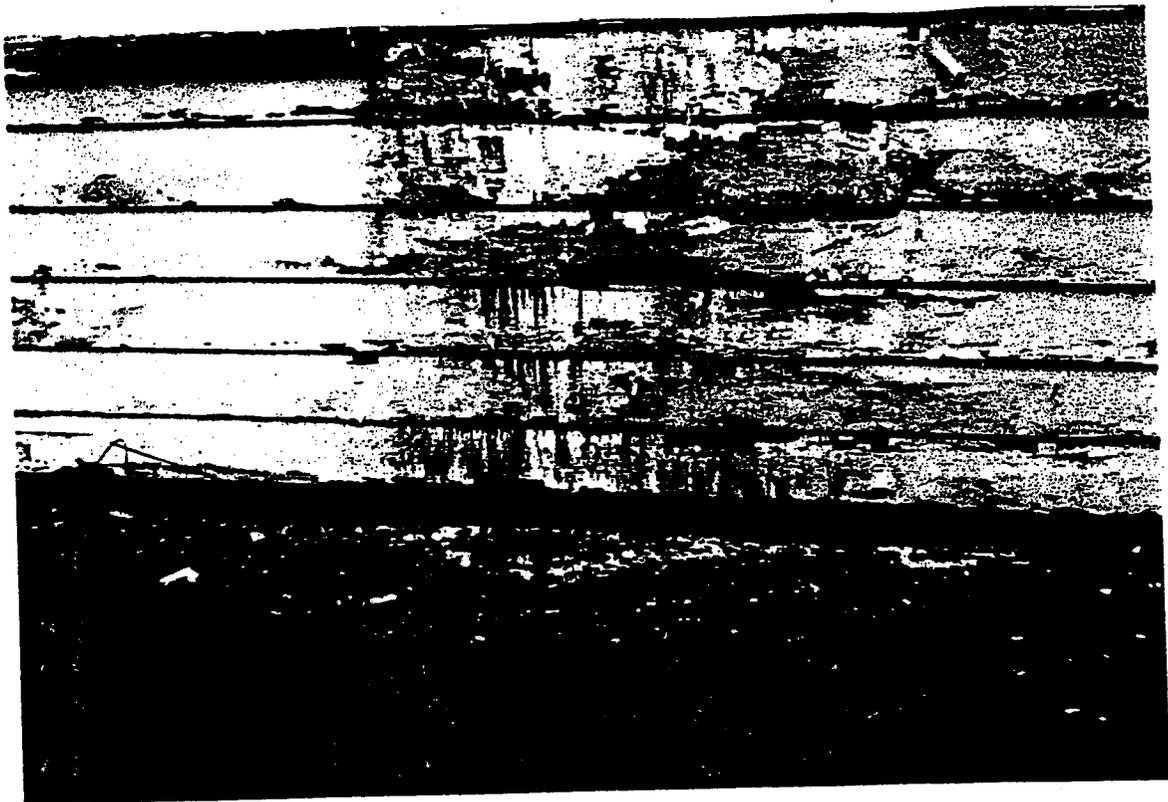
- Lead-based Paint - Accumulation of paint chips and debris was observed on the exteriors of Buildings 150, 151, 134, 135, 136, 22, 110, 29, 16, 56, 48 and 148. All buildings were constructed prior to 1960 and the possibility of lead contamination to soil exists. The remaining buildings located on the subject site were all constructed prior to 1970. Based on the age of the buildings, lead-based paint may have been used on painted surfaces in significant quantities.

(21) Looking North at Deteriorating Paint on Exterior of On-Site Building 148.

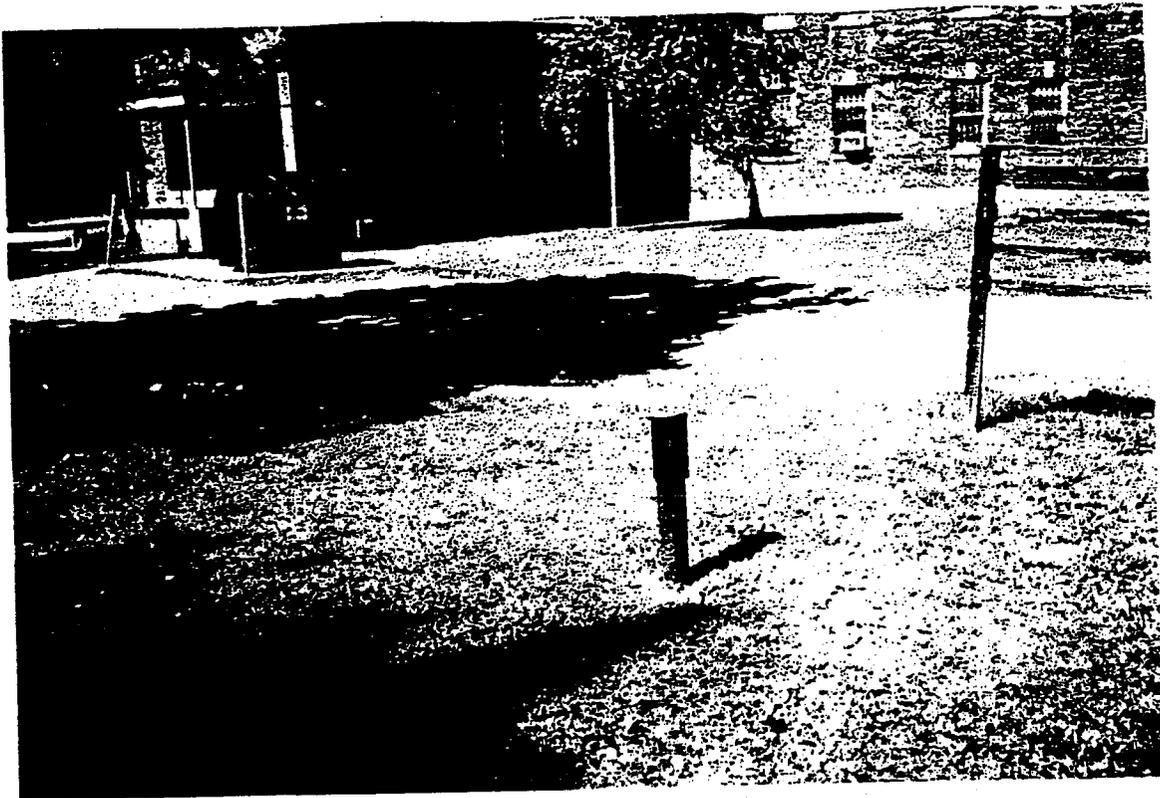
(23) Looking Northwest at Groundwater Monitoring Well Located East of On-Site Building 15.

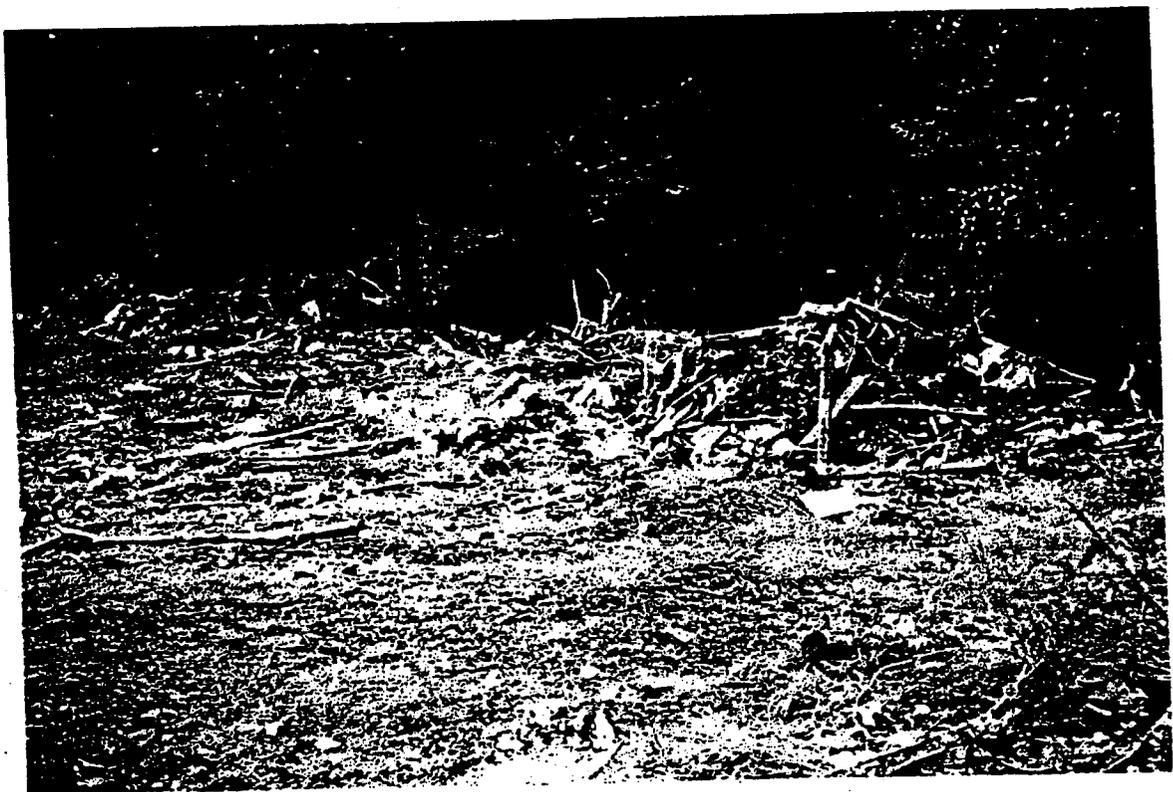
- Area #2 - Located in the northeastern part of the property; northeast of Paint Shop #21. The groundwater is slightly contaminated with iron and manganese, probably a result of leachate. The surface waters showed no contamination directly related to the landfill, whereas the sediment contained metals downstream of the fill. Based on the contamination found, Area 2 was not considered hazardous by NYSDEC standards.

(24) Looking Southwest at On-Site Disposal Area #2 (Dump) Brush/Construction Debris.

Despite the fact that investigation results for these disposal areas did not indicate that they should be classified as hazardous, the landfills should be closed in accordance with NYSDEC Solid Waste Landfill Closure Regulations, 6 NYCRR, Subpart 360. Closure measures would minimize the potential for significant impact to the subject site.

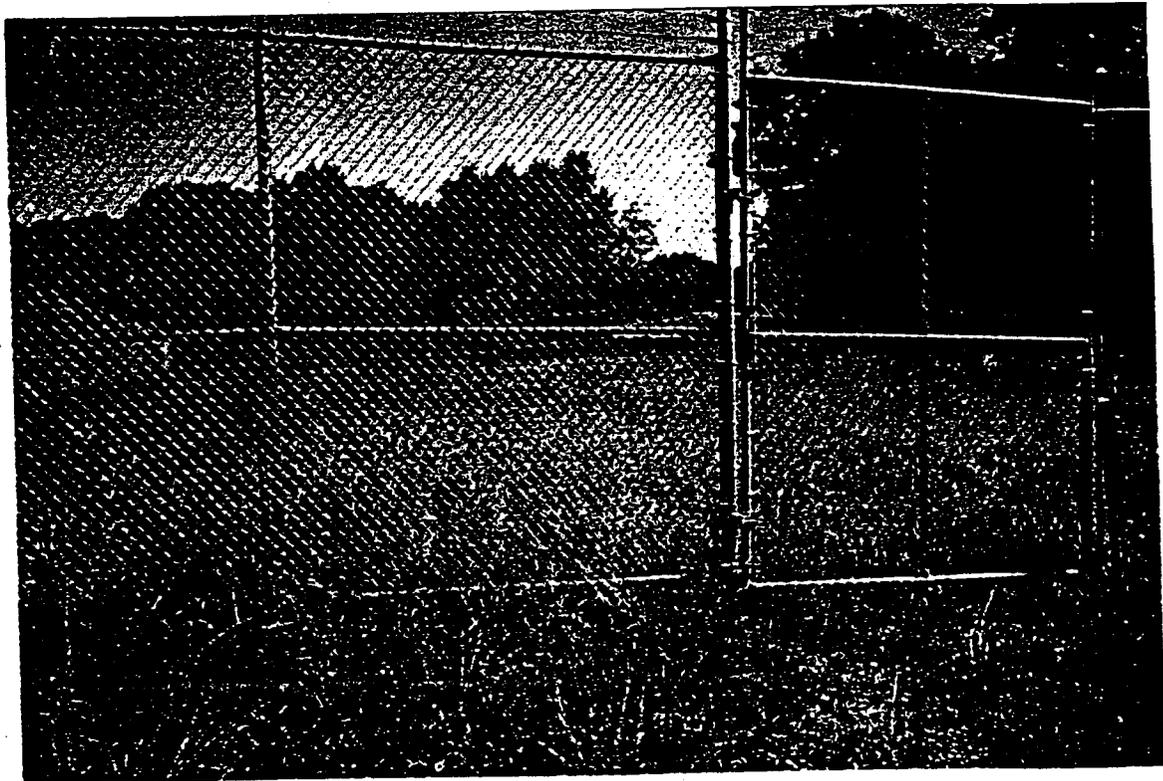
(26) Looking East at On-Site Former Coal Storage Location.

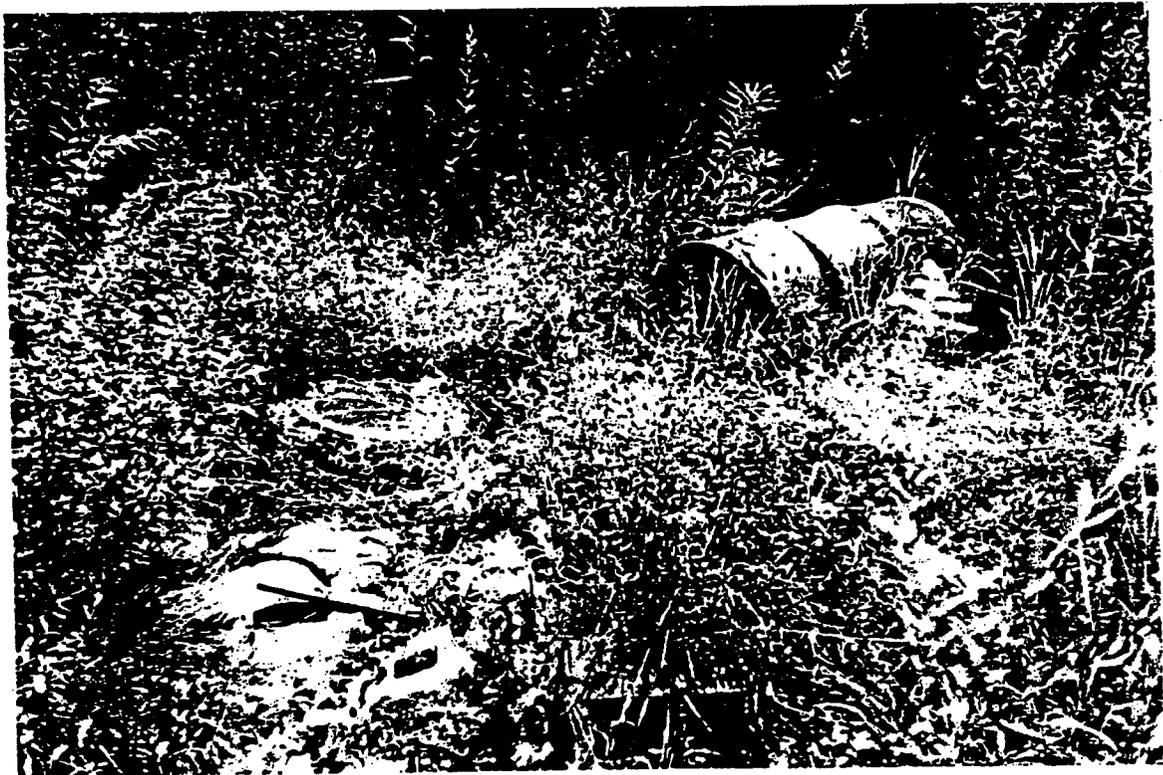
- Adjacent Dump Site - Area #4 dump site, as defined in a report titled "Engineering Investigations at Inactive Waste Sites" for the HRPC is located on an adjacent property to the south of the subject site. This dump site was formerly owned by the State of New York and was a portion of the HRPC. The dump reportedly received municipal waste from the City and Town of Poughkeepsie as well as wastes from the facility itself. This landfill has not been classified as hazardous. However, the potential environmental impact of the landfill on the subject site is considered to be significant.

(32) Looking Southeast at Adjacent South Disposal Area #4.
