Casperkill Community Center Acquisition, Renovation, & Operations Study

FINAL DRAFT

APRIL 28, 2009

SEI DESIGN GROUP
Architecture • Planning • Consulting
187 WOLF ROAD, ALBANY, NY 12205

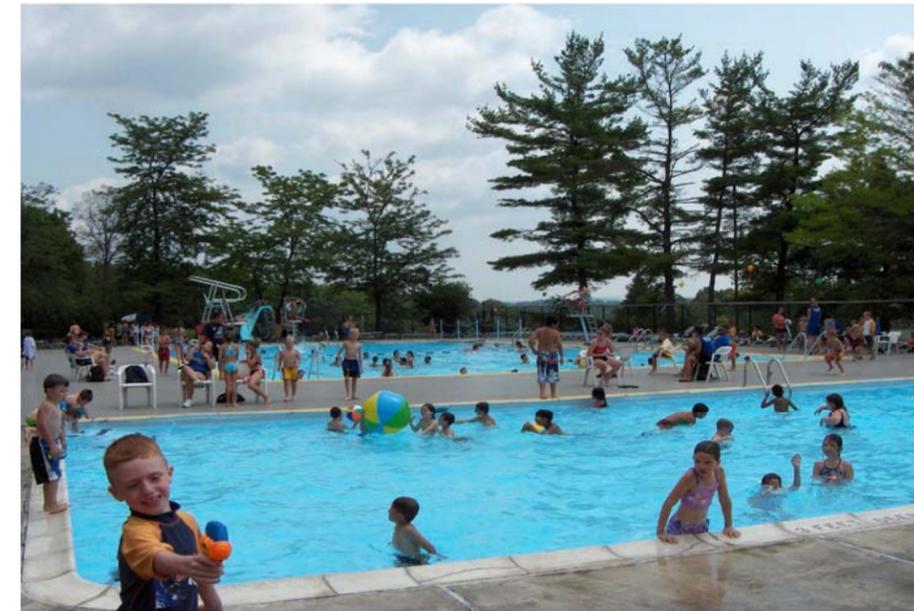
Image 06- Swimming pools

The main outdoor swimming pool appears to have been installed when the facility was initially constructed. This pool is of carbon steel construction with overall dimensions from the inside faces of the pool walls of 50'-0" x 100'-0". The depths in this pool range from 4'-0" x 7'-0". This pool incorporates a roll-out gutter with approximately a one-inch deck to water level.

The pool's current interior finish is a polyester fabric supported PVC membrane lining system, which is believed to have been installed in the late 1980's or early 1990's. The lining system is the Delifol product, which at the time was provided and installed by Recreonics, Inc. of Indianapolis, Indiana. The Delifol product originally carried a ten year warranty and the anticipated life span of the product is approximately twenty-years. At this point, the lining system appears to have reached the end of its serviceable life. This is evidenced by the lining system appearing to be quite brittle and it has shrunk from its original dimensions.

With respect to the pool deck equipment, it was noted that there currently appears to be a one-half meter dive stand at the deep end of the pool. With a maximum water depth of seven feet, we would recommend that this dive stand be removed from service immediately. It did appear, however, that there are adequate numbers of life guard stations as well as ladders in the main pool.

It is important to note, that the main drains in this facility are not in compliance with the recently enacted “Virginia Graham Baker Act,” which established very specific and strict requirements for commercial swimming pool drains and suction outlets.

1. Remove and replace the PVC lining system in the main swimming pool.
2. Remove and replace the existing main drains in the main swimming pool and test the main drain piping to determine its water tightness.

3. Pressure test the return piping on the main swimming pool and perform a static test on the main pool gutter trough. We expect both the piping and gutter to indicate significant leakage in the main pool systems, which would be best addressed by the installation of a stainless steel perimeter recirculation system.

6. Remove two sets of interior stairs located in the main pool and replace with an ADA compliant stair section or Transfer-Tier access stair.
7. Install proper system monitoring gauges and meters for all pool systems.

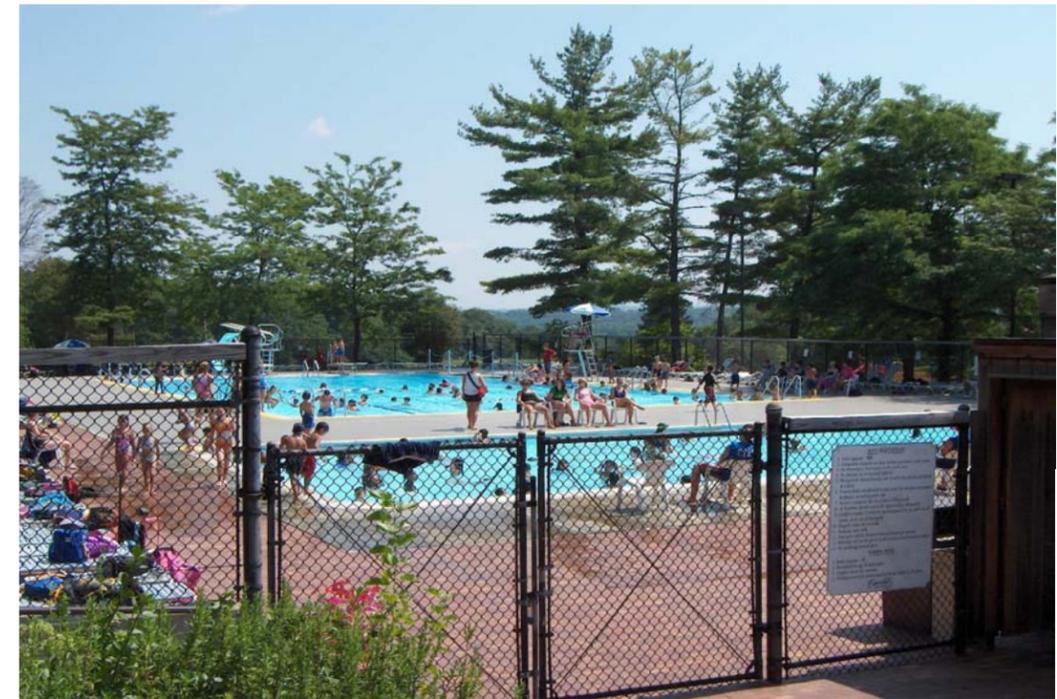
Image 08- Swimming pools

With respect to the intermediate and wading pool, both of these pools are of concrete construction and use a combination of bottom drains and surface skimmers to remove water to the filter systems. Conventional inlet fittings are used as returns back to the pools. The intermediate pool has overall dimensions of 89’-0” x 32’-0” and has a relatively constant depth of three feet. Based on this, the water volume of this pool is approximately 57,446-gallons. With a two hour turnover rate for this type of pool, this would result in a recirculation rate of 477-gallons per minute. We understand the intermediate pool filter system is similar to the main pool with a Harmsco 1200 cartridge filter, which is located in the same mechanical space as the main pool filters. Assuming that this pool is operating at the 477-gallons per minute recirculation rate, the Harmsco 1200 filter is undersized for this application.

The wading pool is of a somewhat irregular shape with the long dimension being approximately 39-feet and the pool at its widest is 22-feet. We have calculated the water volume in the wading pool to be approximately 3,845-gallons. With a recommended turnover rate of 30-minutes, this would equate to 128-gallons per minute as a recirculation rate. The filter system for the wading pool is

The interior surfaces of these pools are painted and it is unknown whether the existing paint is epoxy, chlorinated rubber based paint, or some other variety of coating. However, the surfaces on both of these pools appear quite rough and are in need of a major re-work.

Similar to the main pool, none of the main drains or suction outlets in these smaller pools are compliant with the “Virginia Graham Baker Act.” This is a situation that would need to be rectified before any of these pools are put into operation.

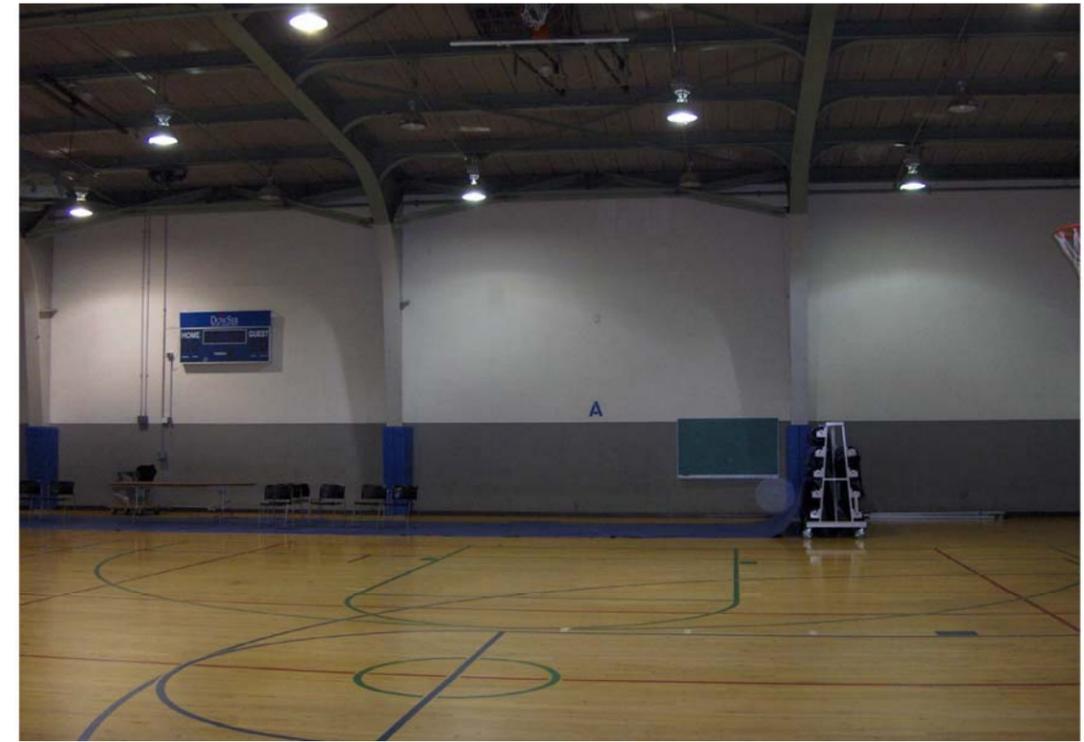
Image 10- Gymnasium

The existing bowling alleys are dated and need refinishing and maintenance. The gymnasium floors are in good condition, but are due for a complete sanding, restriping, and refinishing.

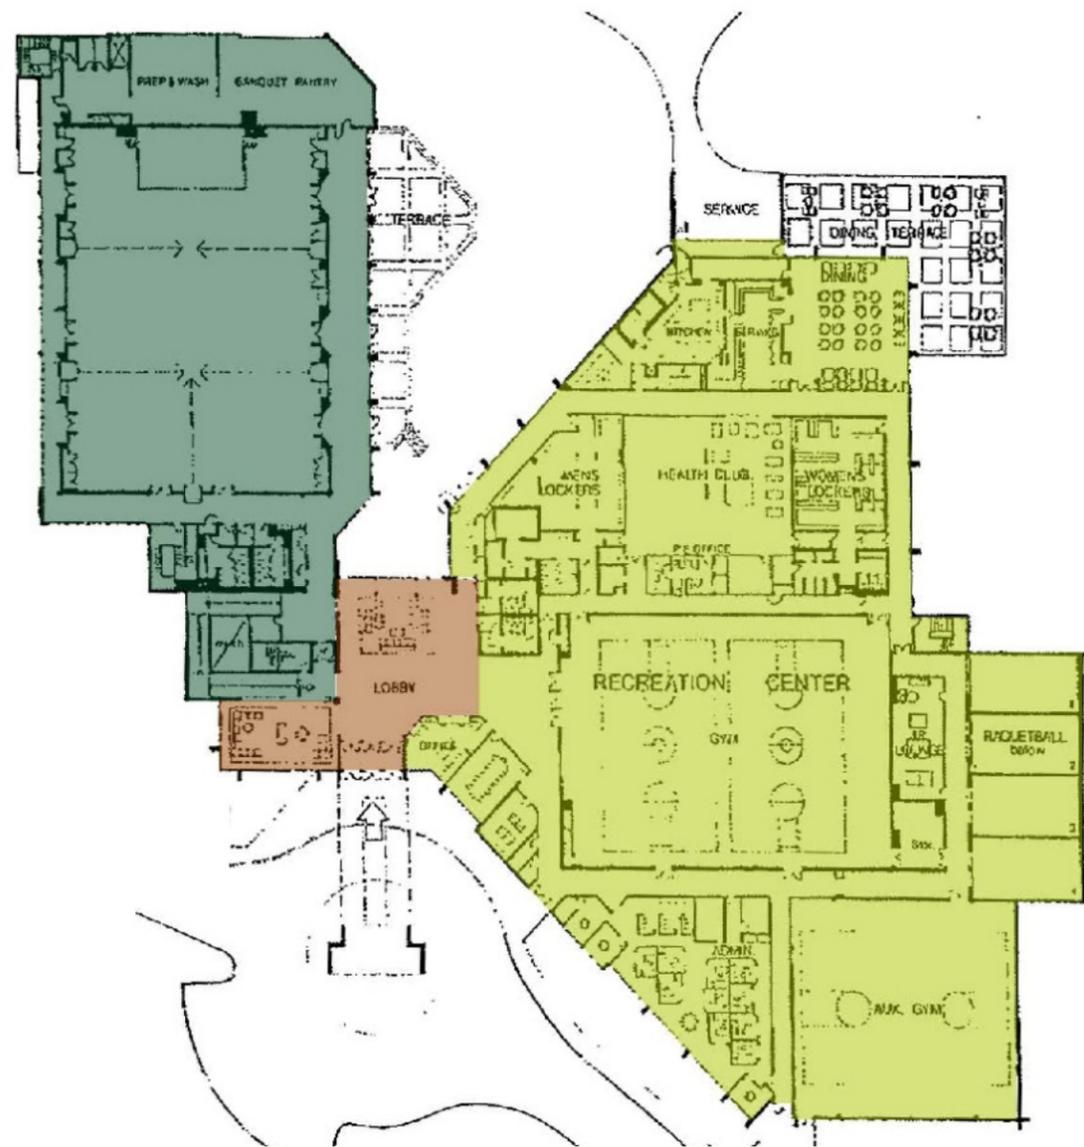
Image 16- Main Level Floor Plan

The Main Level of the building contains the following amenities:

- Conference Center
- Large Commercial Kitchen
- Two Large Gym Stations
- A Fitness Center
- A Senior Center
- Men's and Women's Locker Rooms
- Offices

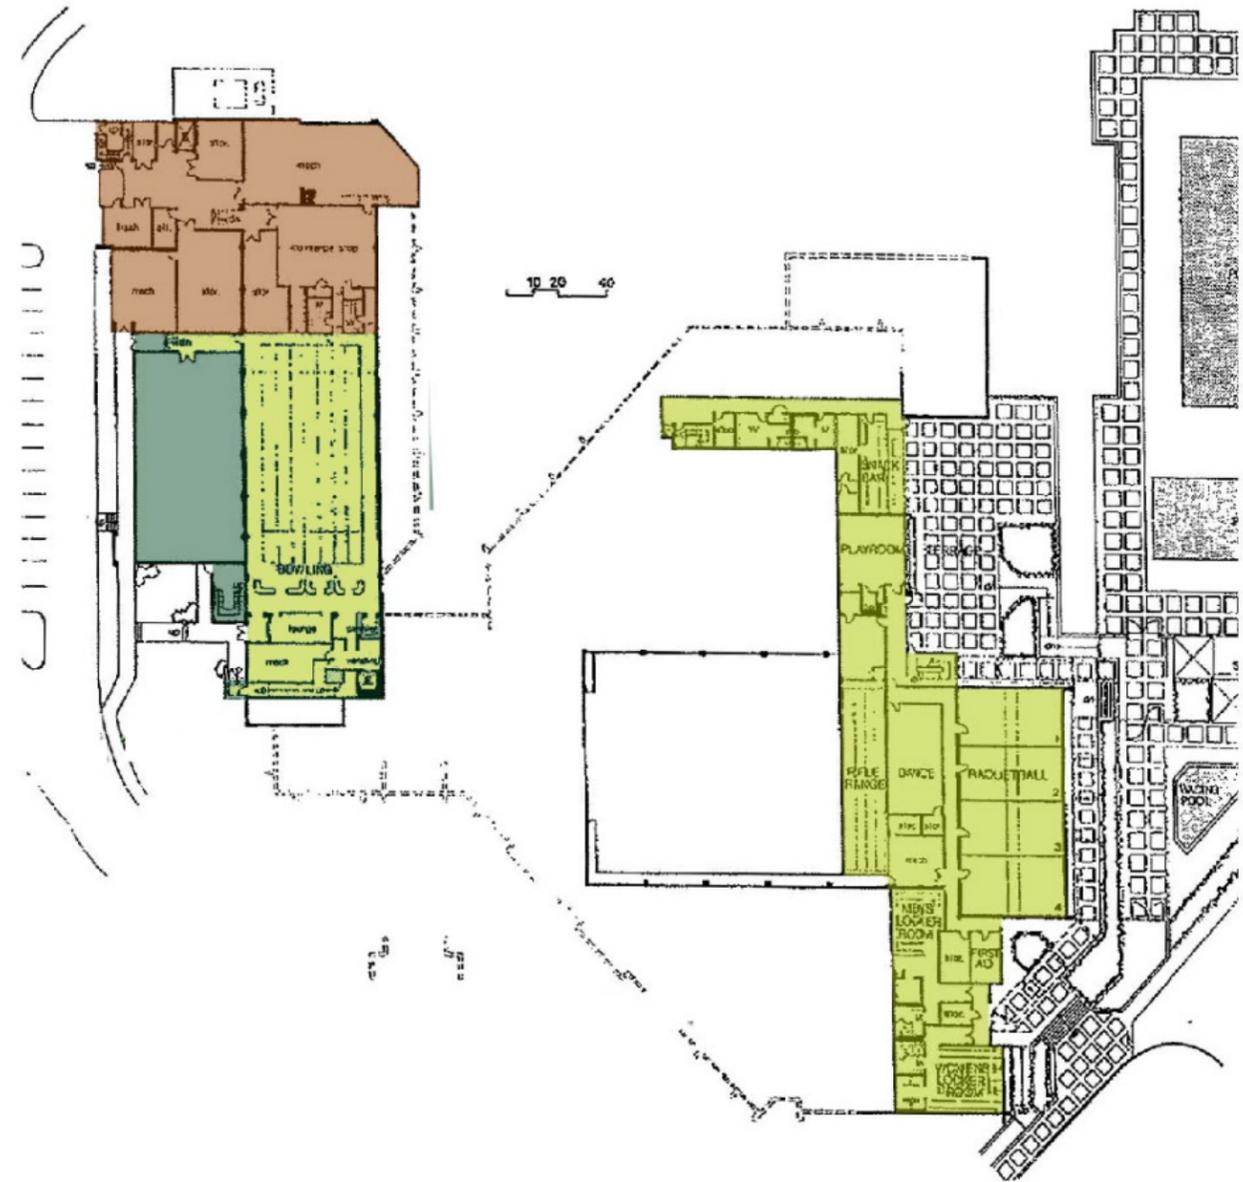
Image 17- Lower Level Floor Plan

The Lower Level of the buildings contains the following amenities:

- Eight Lane Bowling Alley
- A Recreation Room
- A Childcare Center
- Racquetball Courts
- Aerobics Room
- Mechanical Rooms
- Storage

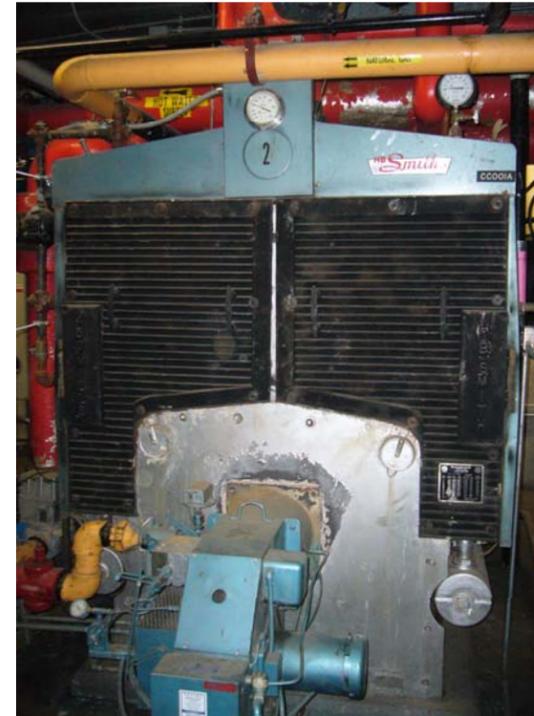
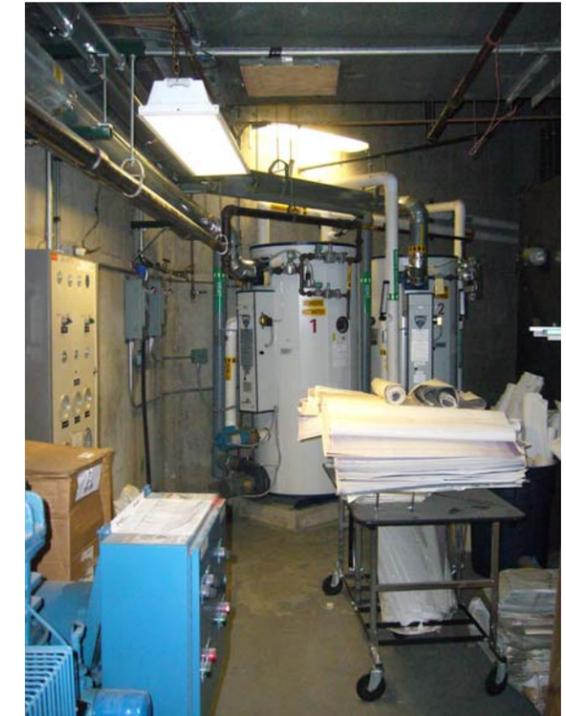
Image 18- Mechanical Systems

Boilers: There are two hot water boilers, HB Smith 450 Mills, located in the mechanical room that serve the entire building. These boilers are original to the building and are in fair condition. The boilers were originally run on #2 fuel oil but have since been converted to run on natural gas.

Hot Water Pumps: There are two sets of hot water pumps to that distribute hot water throughout the building to heating coils. One set of pump is rated at 200 GPM at 45 ft of hd, while the other is rated at 450 GPM at 95 ft of hd. These pumps are in fair condition.

Chiller: There is one chiller, Trane Model CVHE-032G, that serves the entire building. This chiller is rated at approximately 300 tons and was installed in 1983. The chiller is in fair condition.

Chilled Water Pumps: There is one chilled water pump that distributes chilled water throughout the building. The pump is rated at 720 GPM at 125 ft of hd. This pump is in fair condition.

Condenser Pump: There is one condenser water pump, located in the mechanical room that circulated condenser water between the chiller and the cooling tower. The name plate data could not be read on the pump but it is estimated at 900 GPM.
