Hudson Heritage Project

Building Demolition Application

Route 9
Town of Poughkeepsie
Dutchess County, New York

January 14, 2016
REVISED
February 24, 2016

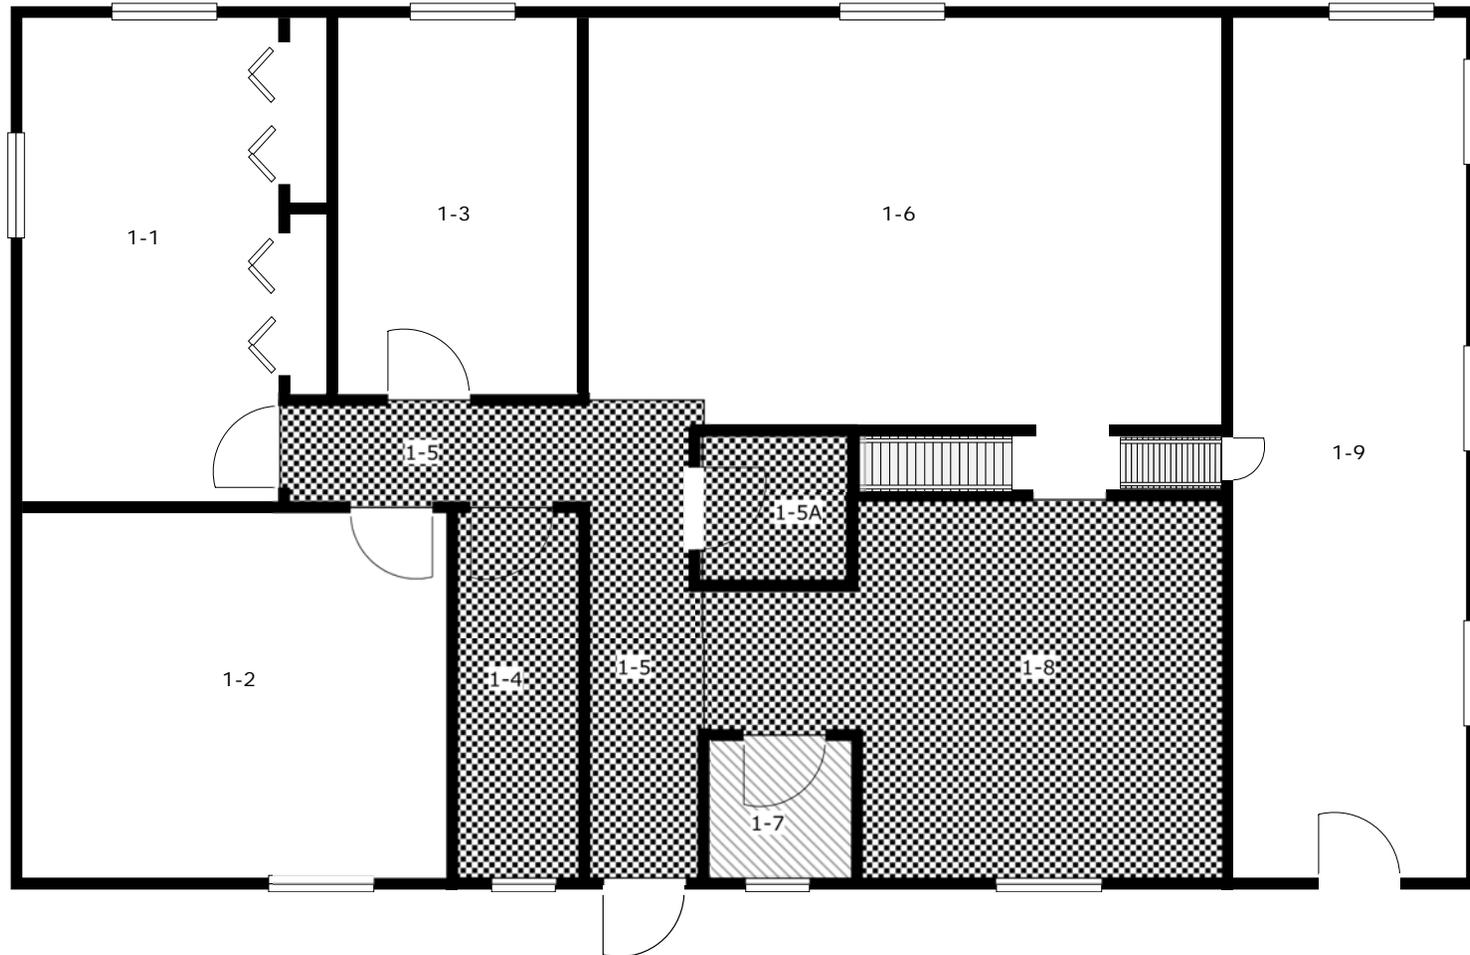
EFG/DRA HERITAGE, LLC
FORMER HUDSON RIVER PSYCHIATRIC CENTER
3532 NORTH ROAD, POUGHKEEPSIE, NY 12601
STAFF HOUSE 23
FIRST FLOOR

1. ACM Shingle Debris on the Ground Throughout the Perimeter of Staff House #23.
(See Report For Details)

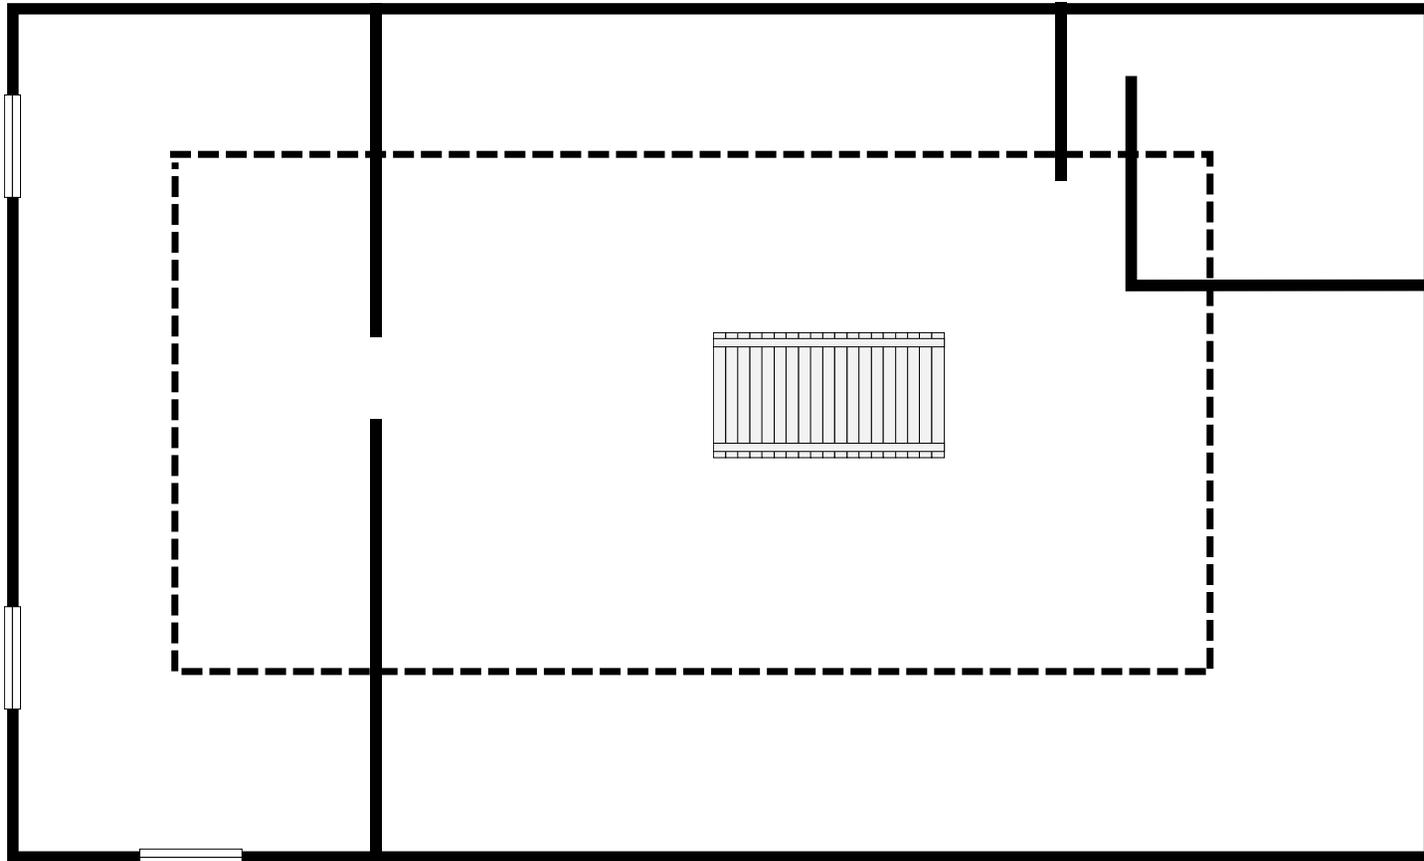
EFG/DRA HERITAGE, LLC
FORMER HUDSON RIVER PSYCHIATRIC CENTER
3532 NORTH ROAD, POUGHKEEPSIE, NY 12601
STAFF HOUSE 23
BASEMENT

= ACM Sheet Flooring
(See Report For Description)
